Thomas Fork Creek

Thomas Fork Creek Implementation to Rehabilitation

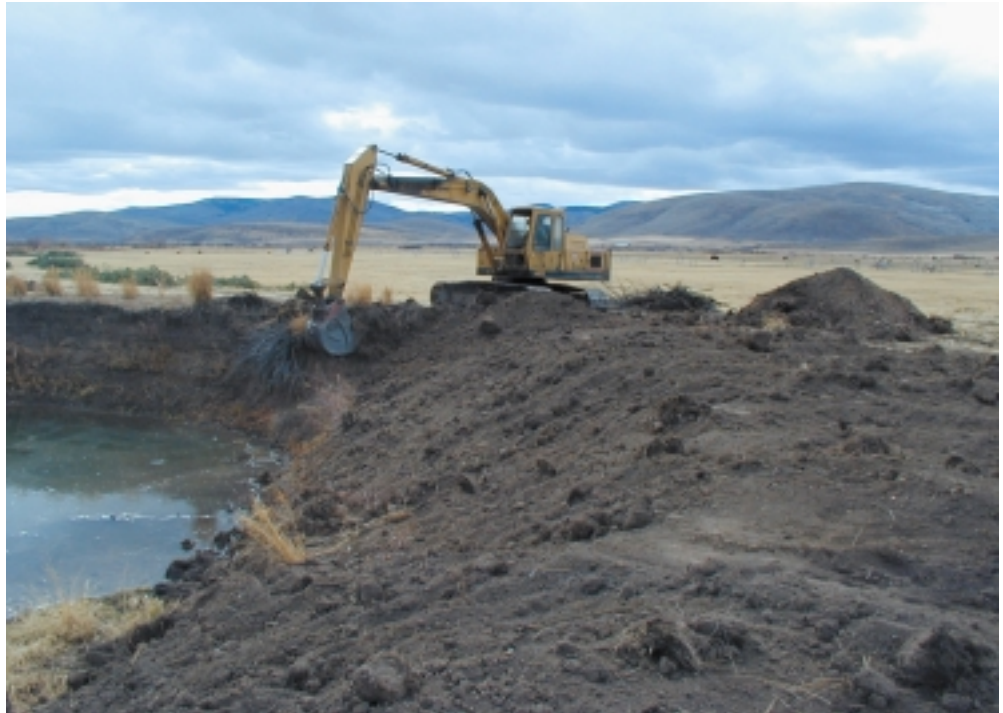
FIGURE 2 *Photo 1. Heavy equipment used to move soil and place large rocks for stream bank stability.*

Stream banks that have been denuded of riparian vegetation are quickly eroded and have a slope face of near 90 degrees. Heavy construction equipment is used to reduce the angle of these banks to a more stable slope. Often a 2:1 or 3:1 slope is suggested by the NRCS as suitable for revegetation of riparian species. Reducing the slope further enhances the probability of revegetation but reduces the number of farmable acreage. Photo 1 illustrates the effect of bank shaping. Left of the trackhoe is a vertical face nearly 10 feet above the Thomas Fork Creek (at normal flow). The reduced angle of the bank provides more floodplain for high flows and dissipates energy associated with those flow events. Once the angle of the banks has been reduced to a less critical slope other techniques are applied which help to keep the stream bank from reverting to a 90-degree angle.

Soil disturbed on stream banks is covered to prevent erosion during rain events or spring runoff. Native rock is placed by tractor bucket over the exposed soil. Local quarries provide the rock, which is hard, angular and dense. This composition is resistant to weathering and high flows. Typically, rock used for this purpose is 8-12” in diameter (Photo 2). This technique does not provide a desired end result but rather a temporary protection from wind and rain until grasses and other vegetation can take root and further stabilize soil and uptake nutrients. The toe of the slope also benefits from the same technique as the upland slope. Rock quarried from the same

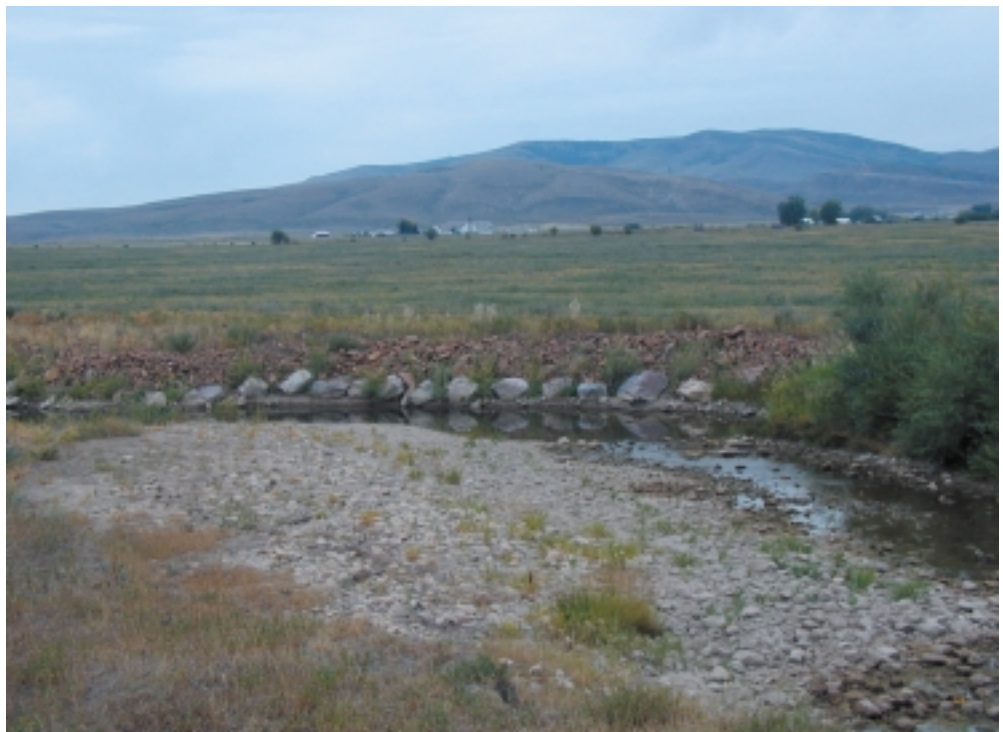
FIGURE 3 *Photo 2. Toe armoring and rip-rap bank protection techniques*

location is laid end to end along the toe of the slope at the water's edge. This rock, like that used for rip-wrap is hard, angular, and dense but of greater diameter. These rocks are typically 2-3 feet in diameter and placed by trackhoe, one at a time rather than by the bucket load. (Photo 2).

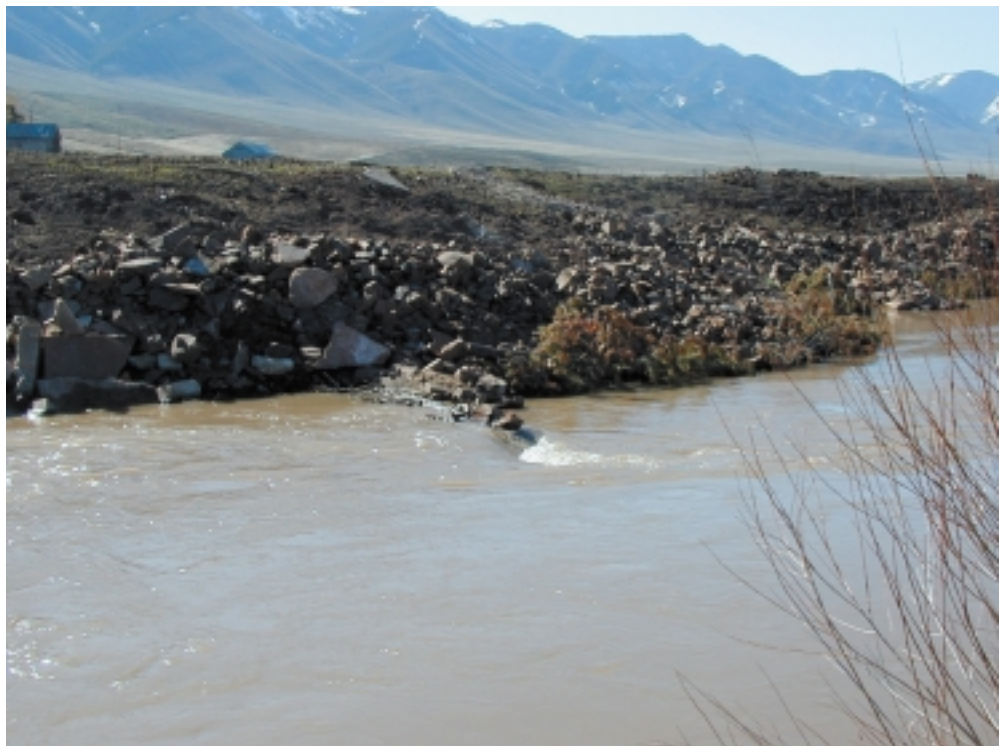
FIGURE 4 *Photo 3. Flow deflector or 'bank barb' diverting flow away from sensitive areas*

Flow is diverted away from sensitive banks with the use of flow deflection structures (Photo 3). Often referred to as “bank barbs” or “points”, these structures are composed of the same material that covers the exposed banks only larger and placed specifically according to engineered plans. Large rock is laid end-to-end, pointing upstream at a 45 degree angle from the bank. Smaller rock is then placed over the large rock to fill interstitial spaces and reduce flow velocity between larger rocks. A key trench is dug into the bank to anchor these boulders in place.

The purpose of bank barbs is to absorb energy and deflect the flow away from sensitive areas prone to erosion. Energy from the water is dissipated within the rocks rather than diverted to erosion prone areas along the stream bank. The flow of the water is naturally diverted over the structure and away from sensitive areas downstream. Bank barbs are sized depending upon the flow in the channel and bankfull width.

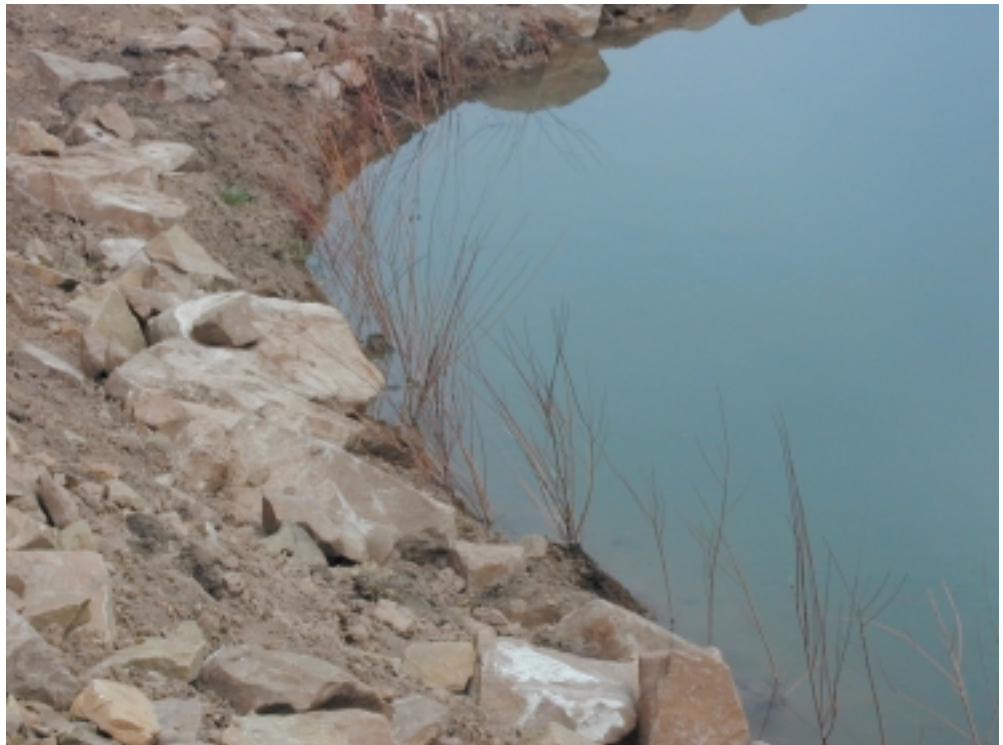
FIGURE 5 *Photo 4. Willow cuttings pressed into toe of bank slope*

Revegetation provides long-term sediment and nutrient reduction in addition to other benefits. Revegetation consists of planting willows (Photo 4) and other on-site vegetation and broadcasting a native seed mix on affected areas. Native seed mix is blended at a local seed mill and consists of Sheep Fescue, Crested Wheatgrass, and Stream bank Wheatgrass. This mix was selected based on site conditions such as soil type and drought resistance of the seed. Willow plantings are cut from healthy on-site communities and pressed into the soil at the toe of all affected slopes. Care is taken to ensure contact is made with the water table at the base of the willow cutting. Cuttings are planted 4 to 6 inches apart during the late fall or early spring. When possible, entire willow stands (willow plantings) and other existing riparian vegetation are transplanted into the toe of the slope along the bank. Planting during dormancy greatly improves chances of survival. Once the soil has been disturbed, the seedbed is prepared by using a harrowing device (Photo 5). The harrow in Photo 5 is a homemade piece of equipment. A six by ten foot piece of nine gauge chain link is cabled to a tractor or other four wheel drive piece of equipment. Chain link has shown to be optimal in these circumstances due to the fluid nature of the linkage. Larger harrows get snagged on rocks and are less maneuverable in confined spaces. The chain link disturbs only soil as it “snakes” along over the rocks and other protrusions. The seed is broadcast by hand as a final application just prior to snowfall. Seed is broadcast over disturbed soil at the recommended density of 30 pounds per acre then treated by dragging the harrow over the soil (Photo5).

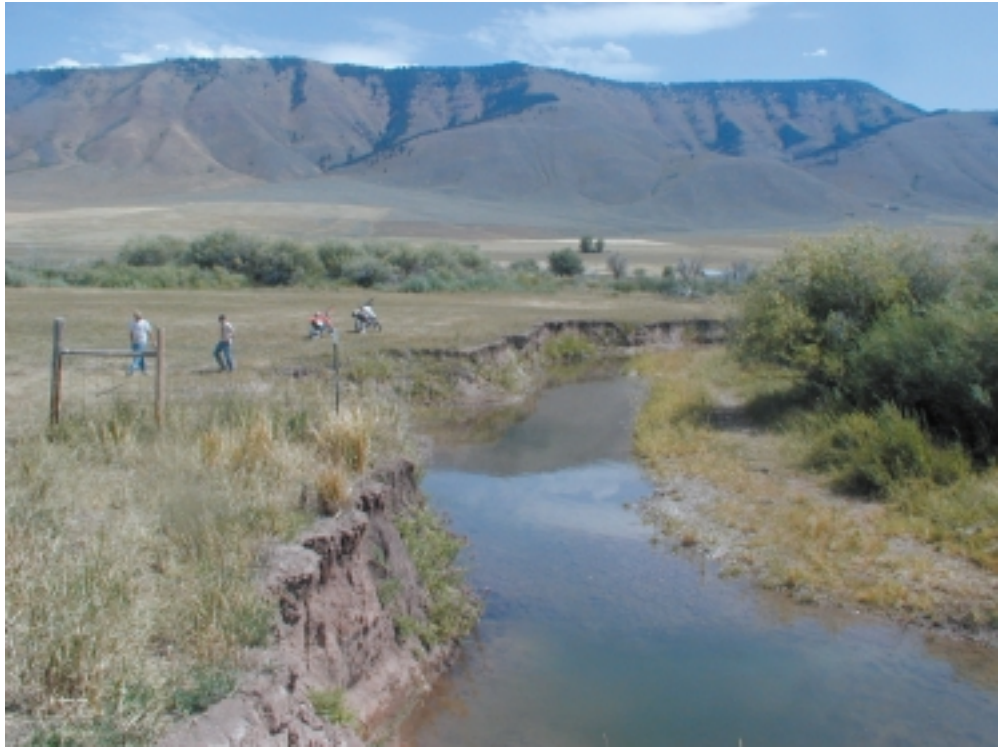
FIGURE 7 *Photo 6. Prior to implementation of BMPs (Fall, 2002)*

This is the third bank stabilization project that Garth Boehme has participated in. Photos 6 and 7 were taken in the fall of 2002 and spring of 2003 after construction. Of particular interest is the width of the channel in these photos. Prior to construction, the creek spanned the width of the channel. After reducing the angle of the bank and constructing a bank barb, the channel width was reduced. Also of interest is the amount of sediment deposited next to the bank. This occurred during a two-month period over the spring runoff. As a result of the recently aggraded gravel bar, new emergent vegetation is starting to take root on the newly established gravel bed. The location of this project has been an asset based on the amount of vegetation present at the site. We have been able to experiment with different methods of revegetation and have seen some encouraging results. Prolific stands of willow and sedge have been available for transplant. We have found that by excavating a hole in the bank next to the water's edge that entire willow communities can be transplanted. This has also held true for sedge and reed grasses. A plug can be transplanted from one location on the project to another without disturbing their life cycle. The benefit of transplanting whole willow plantings can be seen from Photos 8 and 9. Specifically, this corner was treated using a mix of willow plantings and cuttings, which resulted in vibrant growth within six months. The difference in planting and cutting is the number and method used for transplant. A planting involves removal of the entire plant while a cutting is the selective removal of branches. Planting requires heavy equipment to transplant it from one location to another. Cuttings are cut and pressed into the soil at the water's edge. The light colored willow in the middle of the picture on the left-hand side of Photo 9 was the only standing vegetation on this cutbank prior to revegetation. All of the rest were willow plantings and cuttings. Willow cuttings are present in this picture although less visible. This project required treatment of 2163 linear feet of stream bank and construction of 12 bank barbs. Ecological enhancements include three new pool-riffle complexes and re-defined thalweg (deepest point of the channel). Other occurrences of interest at this location include reduction in stream width to depth ratio at three locations as a result of gravel beds forming.

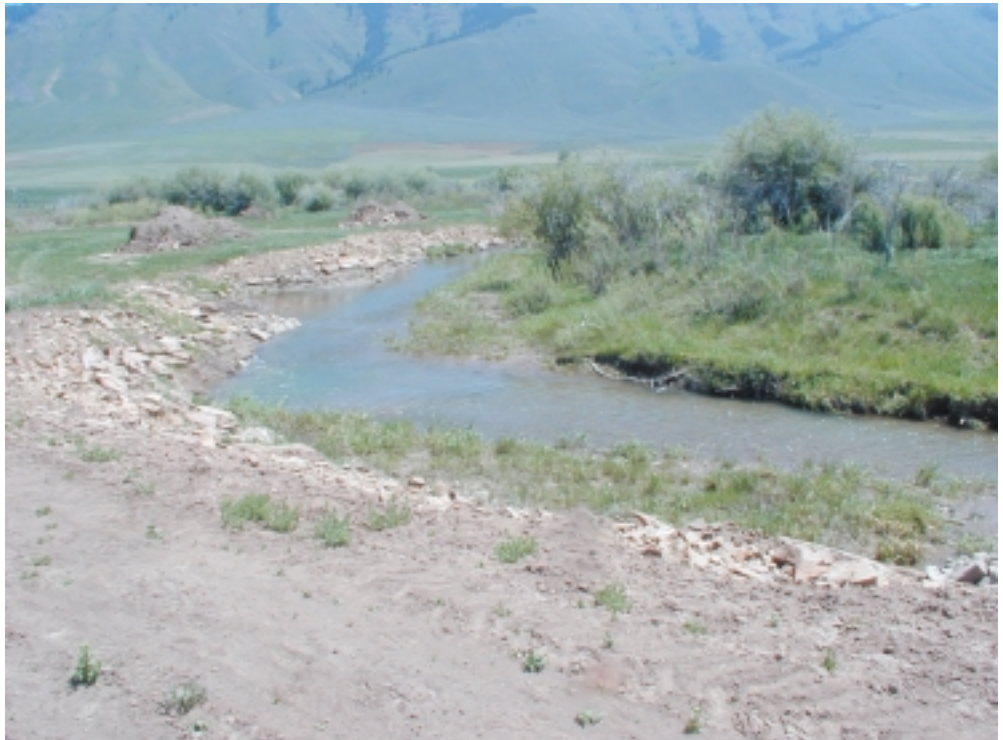
FIGURE 8 *Photo 7. Post-BMP implementation (Spring 2003)*

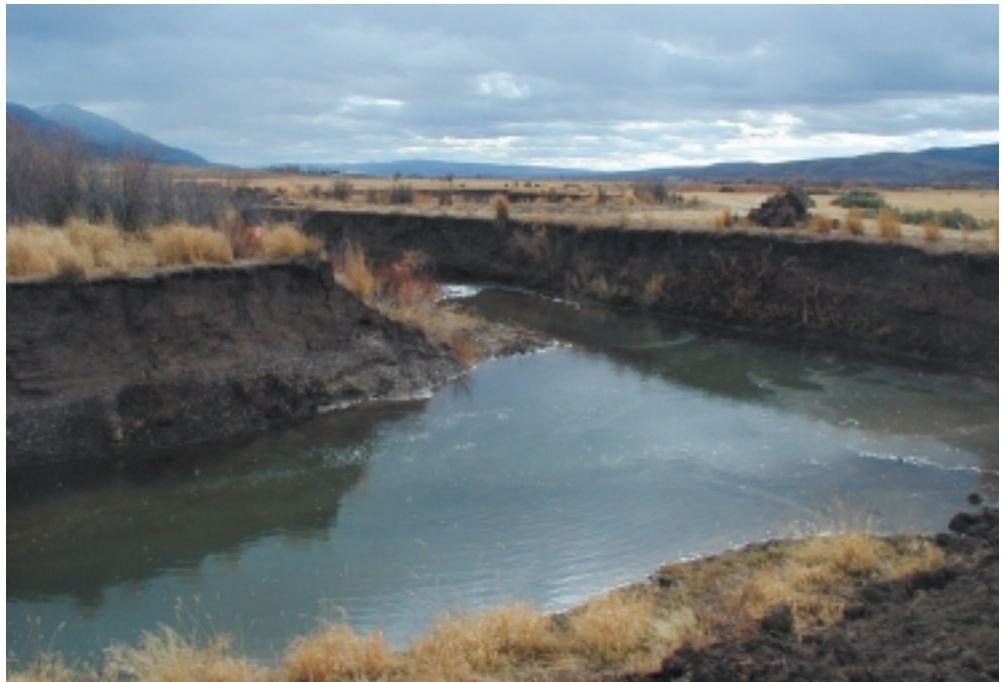
FIGURE 9 *Photo 8. Cutbanks prior to reclamation*

Often banks are found to be eroding at transitional areas between cutbanks on corners. Photos 8 and 9 illustrate how little time is required for riparian vegetation to re-establish on the banks once the soil is stabilized in place using BMPs (Photo 9). Time lapse between Photos 8 and 9 is roughly six months. Treatments along 4275 linear feet of stream bank and 15 bank barbs were required at this project. Roughly, 2100 linear feet of log revetments were used as additional retention devices at strategic locations.

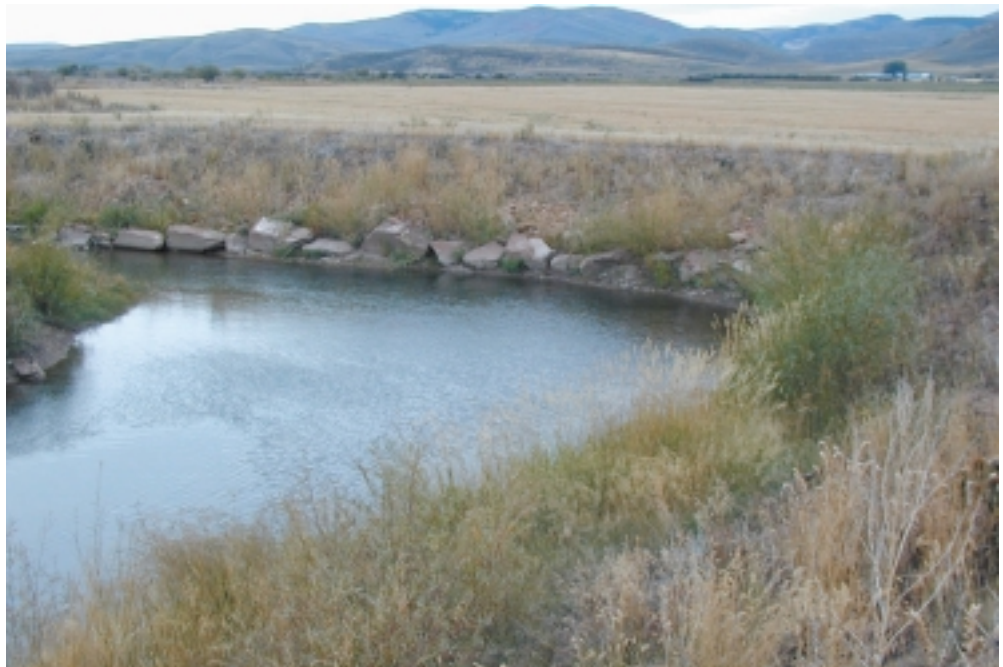
FIGURE 10 *Photo 9. Cutbanks six months after reclamation*

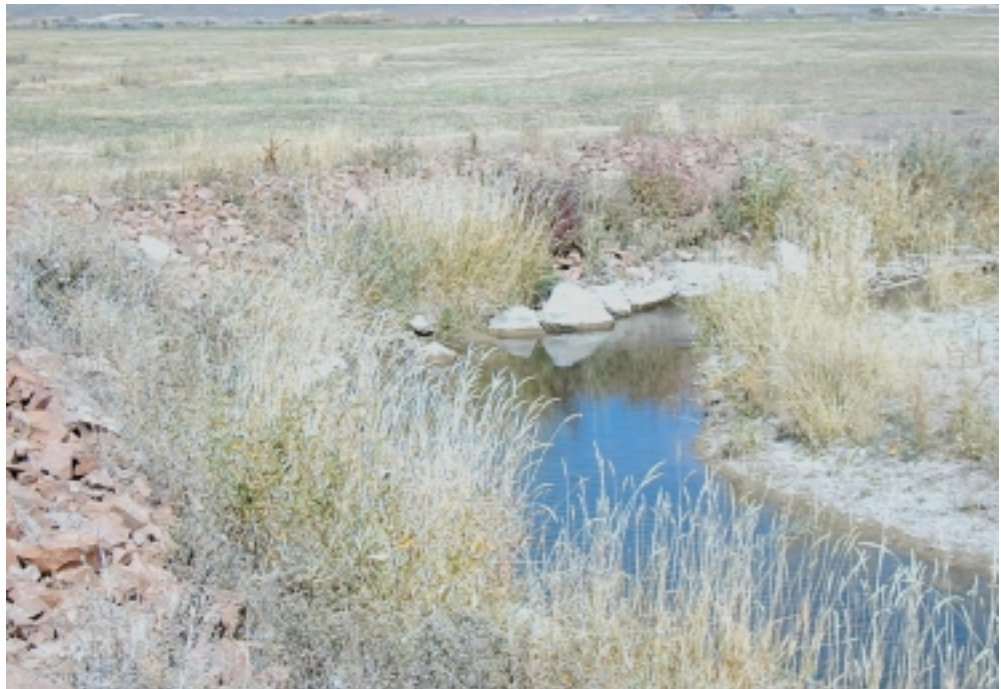
FIGURE 11 *Photo 10. Results of vegetation after five years*

This project was one of the first along Thomas Fork to address bank stability. Now, five years old, riparian vegetation is abundant along treated and untreated banks. Photo 10 shows the ability of vegetation to stabilize the bank when treated and protected. This picture also represents a dichotomy in rehabilitation. The vegetation in the picture along the banks is Canary Reed Grass, which is a non-native species. In some locations this species out competes the native grass seed mix applied. Rock provides a temporary solution until a more permanent vegetative cover can be established. This bank was rip-wrapped from top to bottom to keep soil in place until vegetation could establish. Despite the fact that in purist terms it should not be used as a remedy for erosion, rock rip-wrap accomplishes the objective of bank stabilization and nutrient uptake and is particularly useful in areas where aesthetics are not as important as functionality. Conversation with landowners along Thomas Fork has indicated they lose about three feet of valuable farm ground each year as a result of erosion. After BMPs are implemented that number is drastically reduced. Further illustration of the benefit of BMP implementation can be seen in Photo 11. The left side of the picture is Heber Boehme's property after treatment with BMPs and allowing re-establishment of riparian vegetation. The right side of the picture lacks BMPs and an alternative to grazing management. Prior to treatment both sides of the fence looked like that on the right side. Clearly, implementation of BMPs and landowner cooperation results in a distinct improvement over the converse. Bank shaping and other treatments on this project totaled 1743 linear feet with placement of 13 bank barbs.

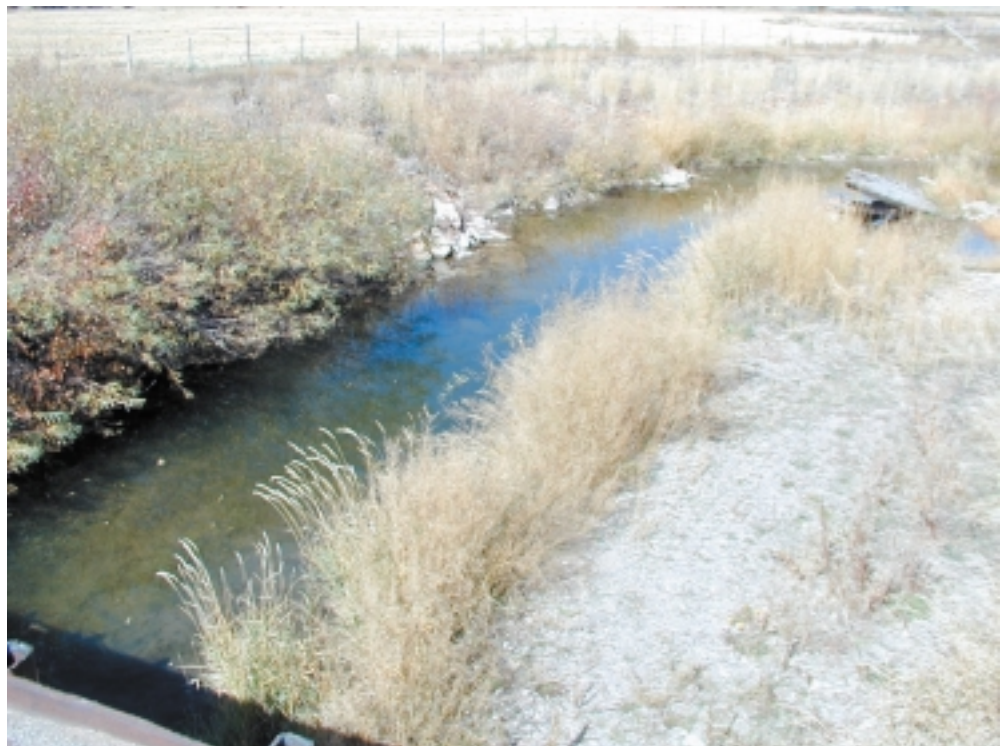
FIGURE 13 *Photo 12. Vegetation and stream channel after six years*

Garth's first bank stabilization project was completed in conjunction with several other projects that seek to keep sediment and nutrients out of the Thomas Fork. Photo 12 was taken six years after treatment. The photo was taken at the downstream terminus of the project from the bridge installed during previous projects. This photograph illustrates the benefit of implementing BMPs on eroding banks and the resulting effect on the channel. Like many other locations along Thomas Fork Creek, this stretch was much wider during low flow before BMP implementation. Prior to construction of upstream bank barbs and bank shaping at this site the channel possessed a much greater width to depth ratio. Post-BMP implementation has found the streambed in a more confined channel with an aggraded gravel bed only submerged during higher flows. Monitoring indicates that prior to construction the streambed was over twice the current width. The right edge of the photo was the edge of the creek prior to rehabilitation. Rip-wrap placed as temporary treatment has been secondary in benefit to riparian vegetation. This location has a strong community of willows on the opposing bank where previously only vertical bank was present. The bank on the left-hand side was shaped, then rip-wrapped. After several years the rip-wrap is no longer visible and has been completely overgrown with willow communities. The other benefit in this area is the gravel bed, which has aggraded vertically and horizontally and reduced the channel width. Treatments at this location include: bank shaping along 1500 linear feet, 900 feet of log revetments and 15 bank barbs constructed at strategic locations. In addition, 2000 linear feet of fence were erected for livestock exclusion.

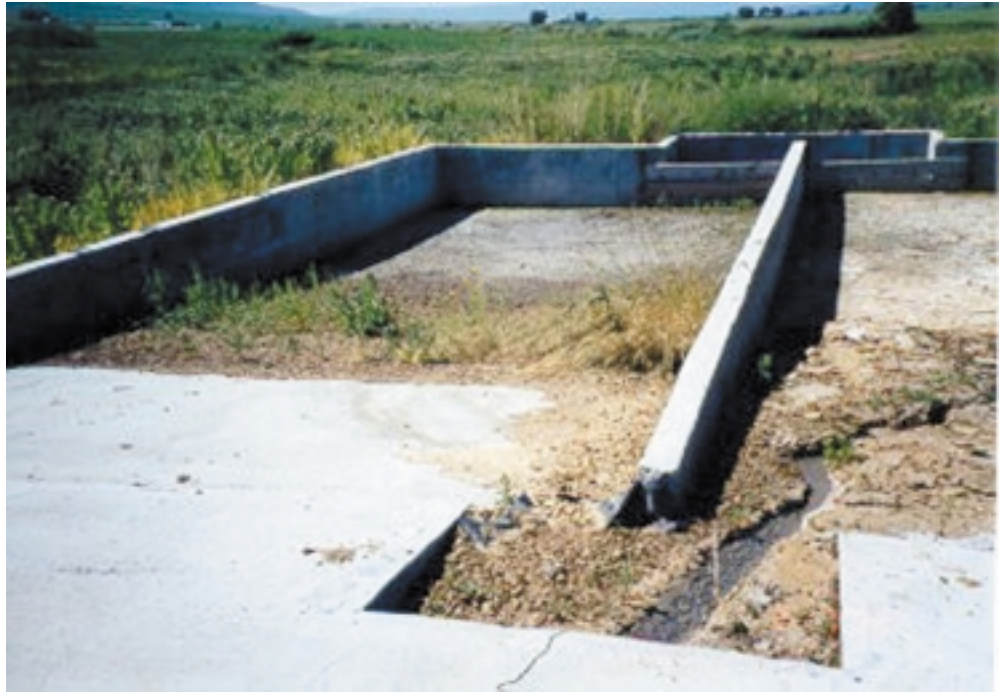
FIGURE 14 *Photo 13. Manure bunker with wetland in the background*

In addition to bank stabilization and BMP implementation on Thomas Fork, other upland projects have been completed as well. A manure management facility consisting of a manure bunker, separator and constructed wetland have been completed to reduce nutrients entering Thomas Fork (Photo 13). The constructed wetland helps to take up much of the nutrients that previously entered Thomas Fork.

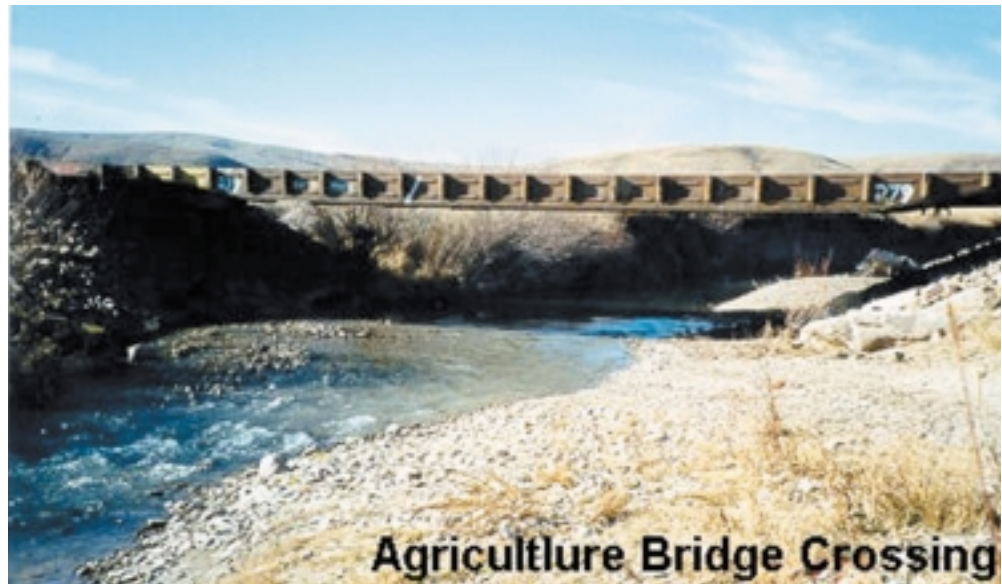
FIGURE 15 *Photo 14. Bridge crossing made from an old railroad flatbed car. Since this photo was taken, vegetation has taken over the flood plain where the photographer stood.*

A bridge was also constructed at this location. Prior to construction, a dairy operation was located on a bluff overlooking the Thomas Fork Valley. Previously, all waste products from the dairy operation were pushed over the bluff adjacent to the stream channel where they accumulated until such time as they were needed to fertilize cropland. The material was scooped up and deposited in a manure spreader, which was hauled through Thomas Fork to adjacent cropland. To remedy this water pollution problem a nutrient management facility was constructed. Any waste products produced by the dairy are now deposited in the separator where the solids and liquids are directed to different locations. The solids remain in a concrete bunker until they are spread on cropland. The liquids are piped to a constructed wetland where the nutrients can be utilized by plant material. The bridge allows passage over Thomas Fork without contamination from the manure spreader.
